Asbestos Survey Report

V.A. Medical Center - Building 8

February 28, 2005

ARM Project No. 09-102-04

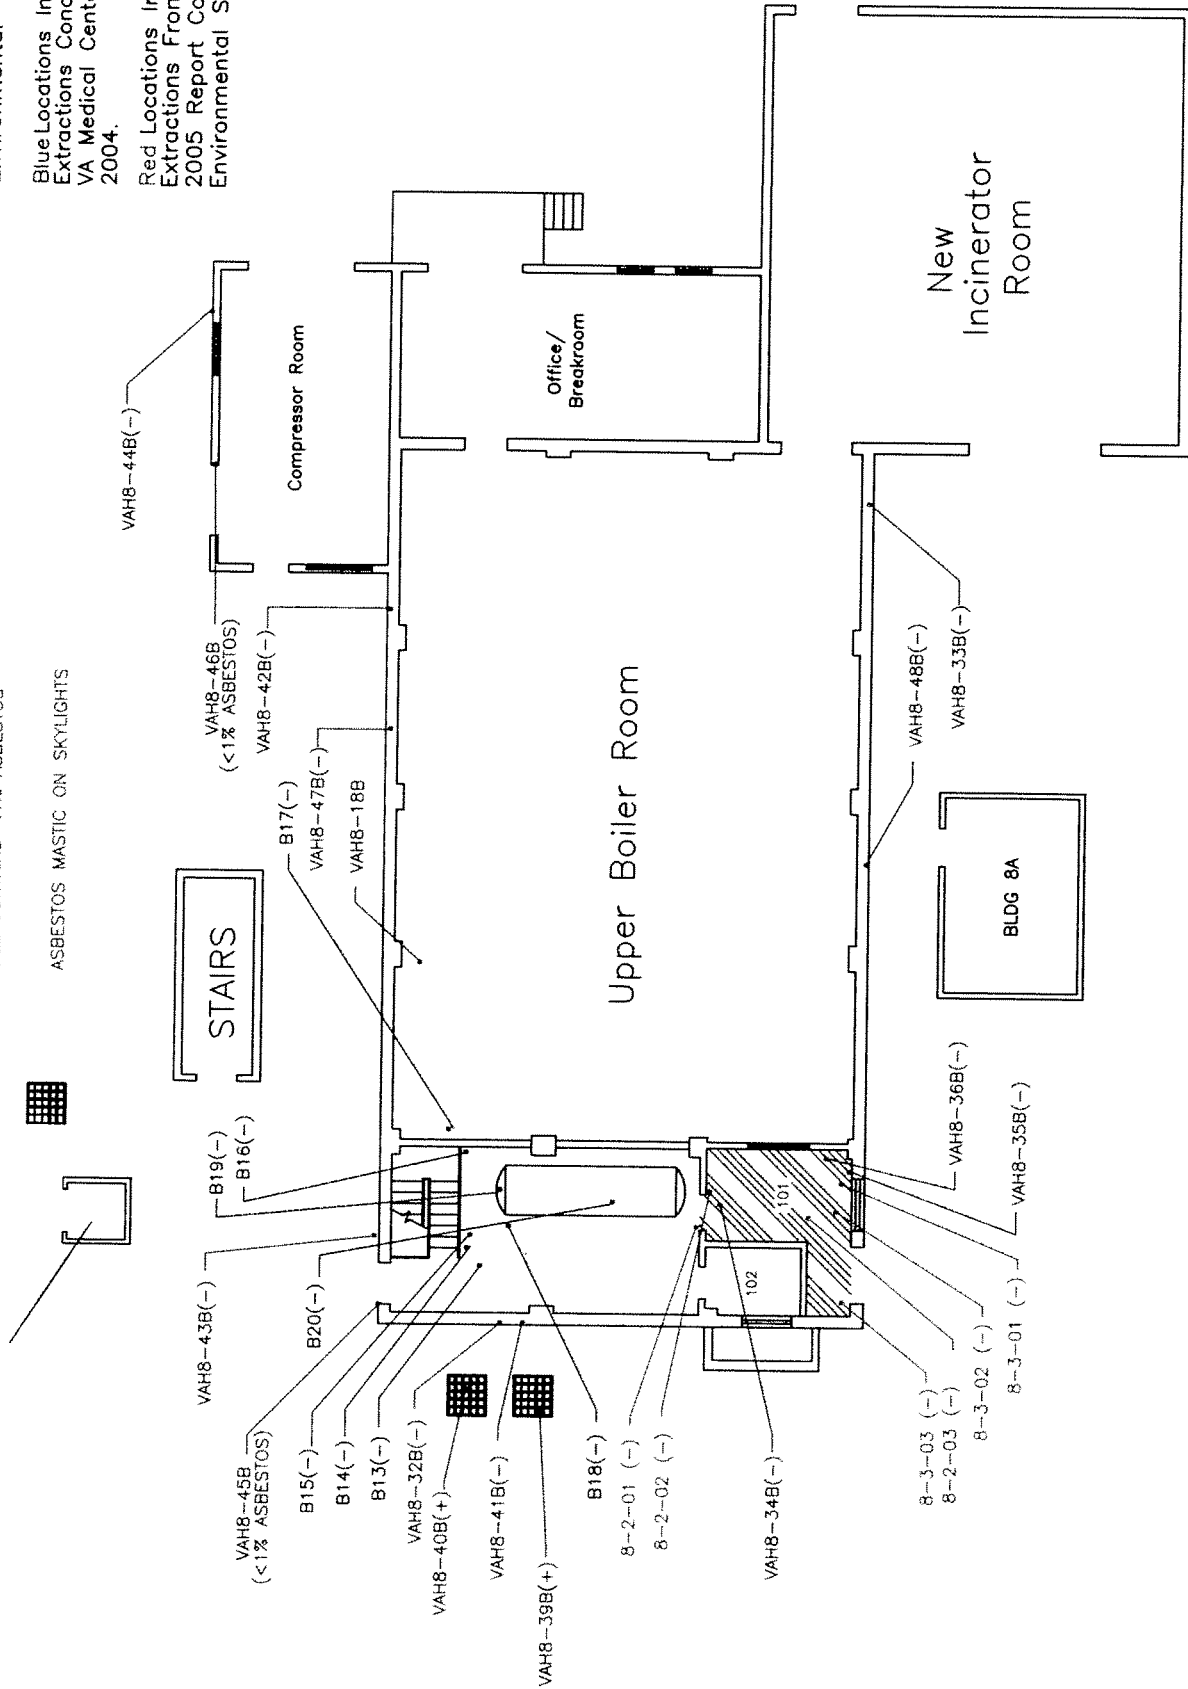
MEZZANINE PLAN - BUILDING 8

W	ASBESTOS BOILER FLUE GASKET
—	ASBESTOS BOILER FLUE INSULATION
■	ASBESTOS ACOUSTICAL MASTIC ON SINK

ASBESTOS MASTIC UNDER 9" TILE.
TILE CONTAINS <1% ASBESTOS

ASBESTOS MASTIC ON SKYLIGHTS

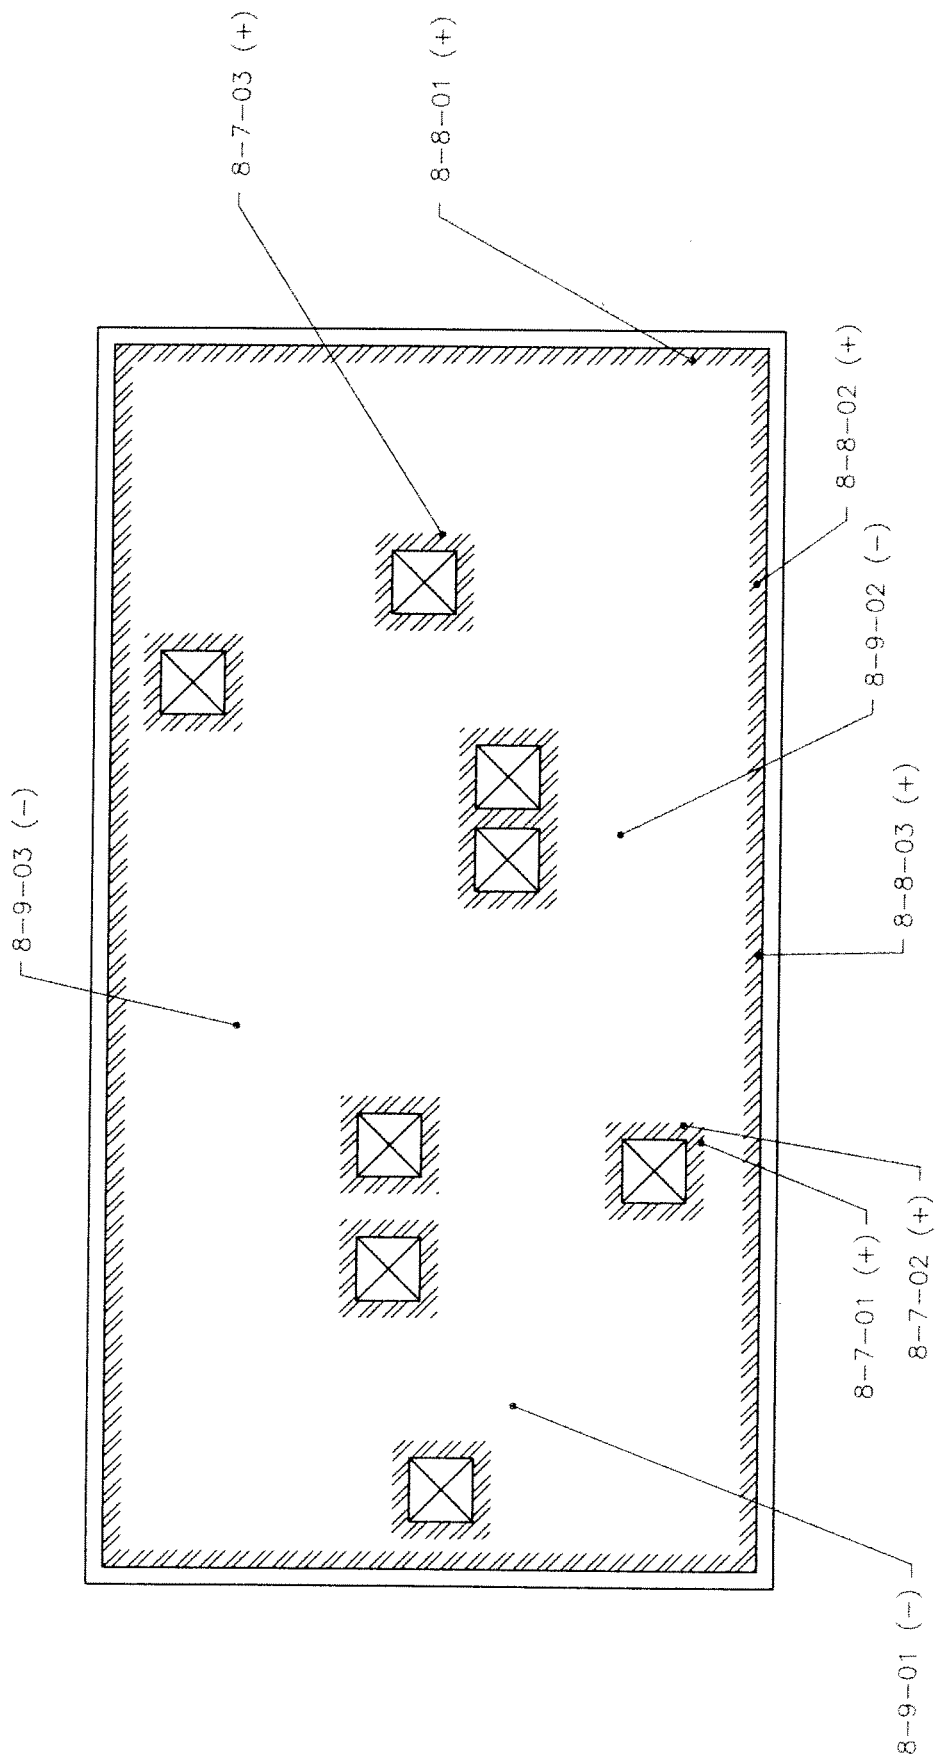
ROOF PLAN - BUILDING 8

GRAY OR BLACK ASBESTOS FLASHING

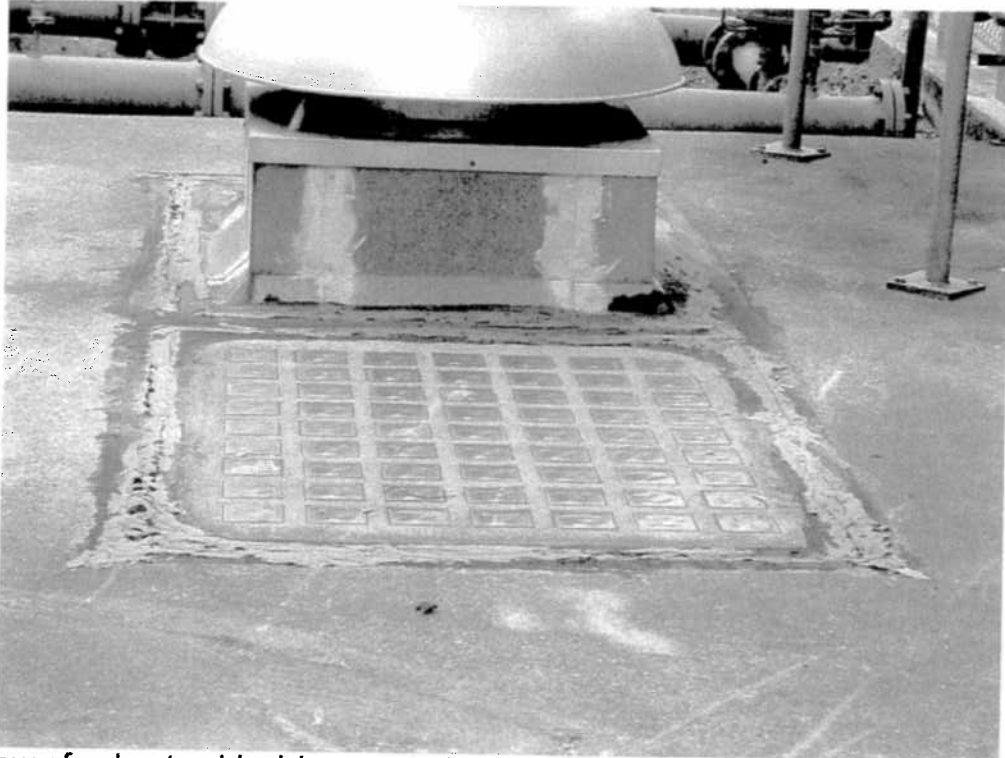
- 3) View of asbestos black/gray exterior weatherproofing around skylights located on the south side of Building 8 in the fenced-in gas pipe compound.

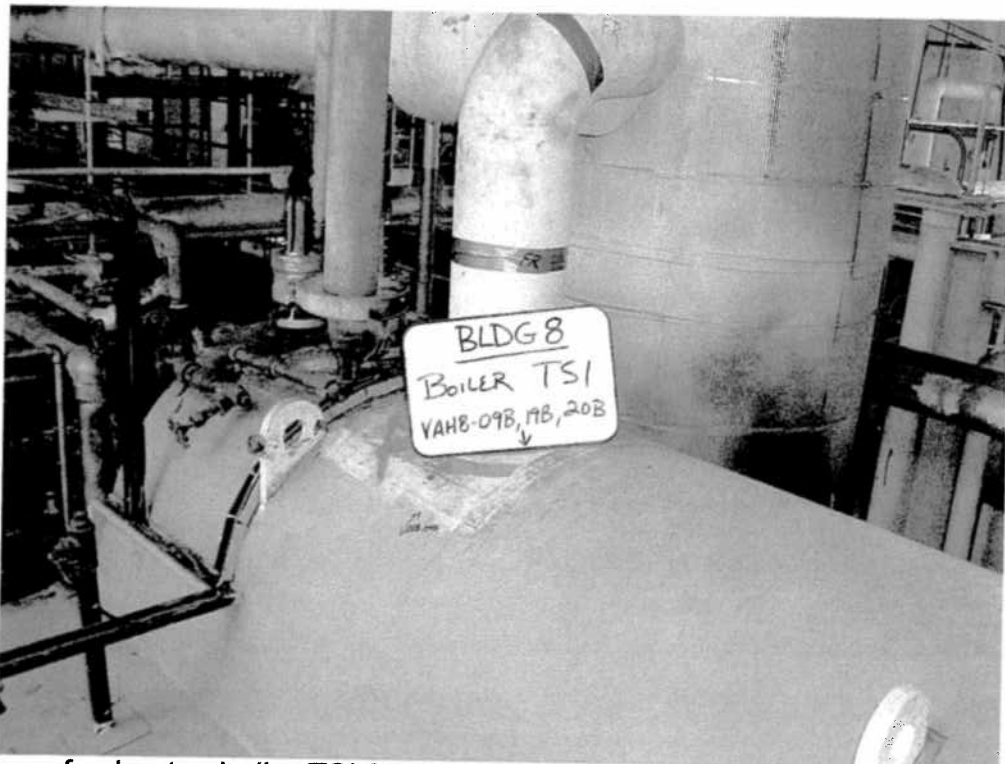
- 4) View of asbestos boiler TSI found on top of a boiler in Building 8. TSI under the metal skin of all boilers is assumed to be the same material unless laboratory analysis determines it to be non-ACM.

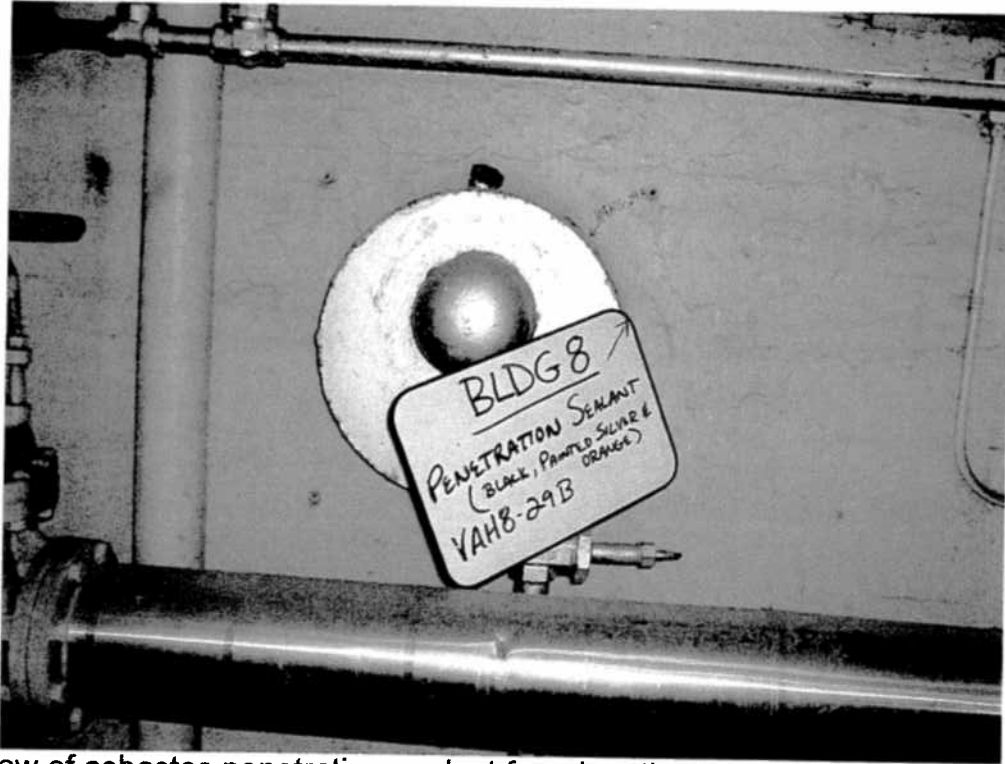
5) View of asbestos penetration sealant found on the south wall in the pump room of Building 8.

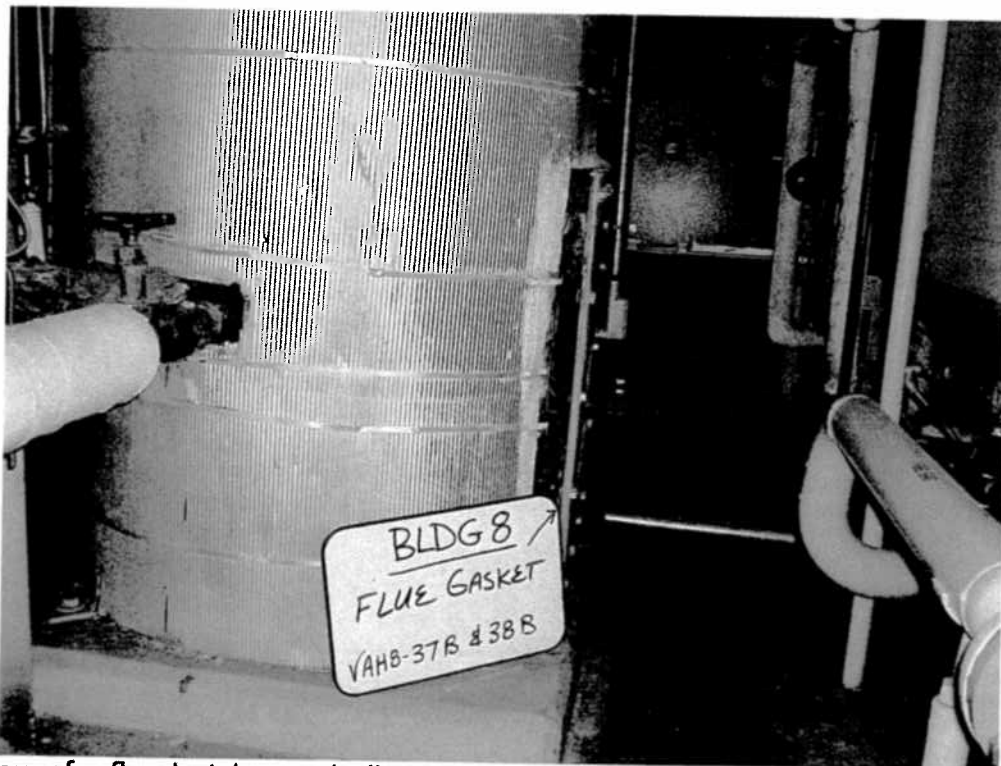
6) View of a flue hatch on a boiler stack with an asbestos gasket in Building 8. These gaskets were found on the stacks for boiler #1 and boiler #2 only.

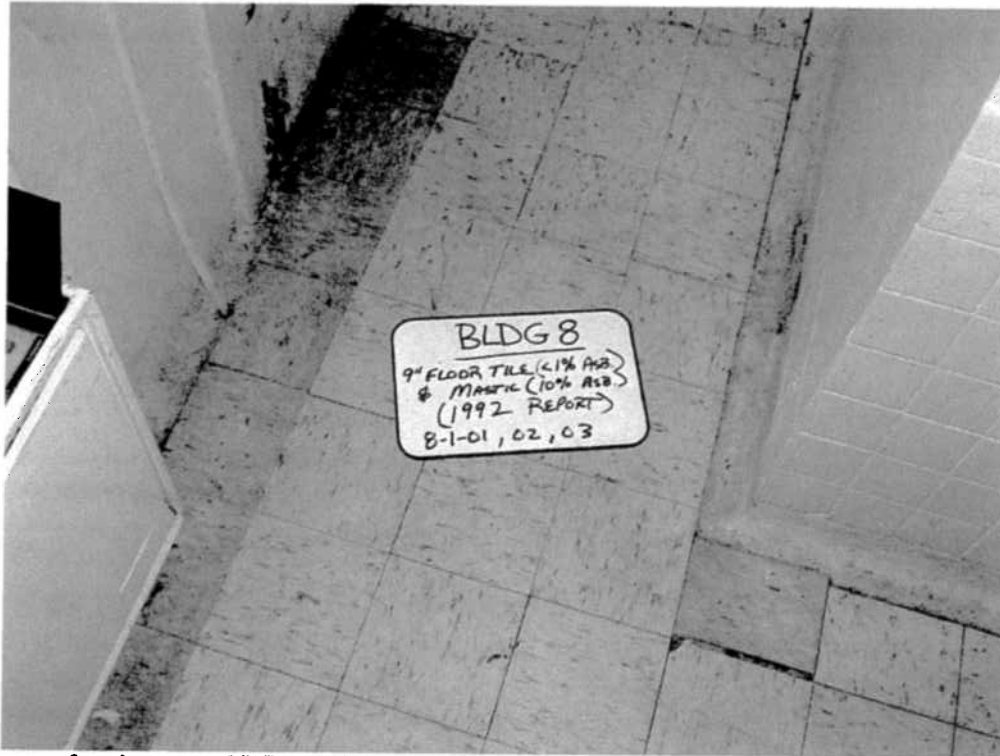
- 7) View of asbestos 9" floor tile (less than one percent asbestos) found in Building 8 during a 1992 inspection. Mastic is 10 percent asbestos.

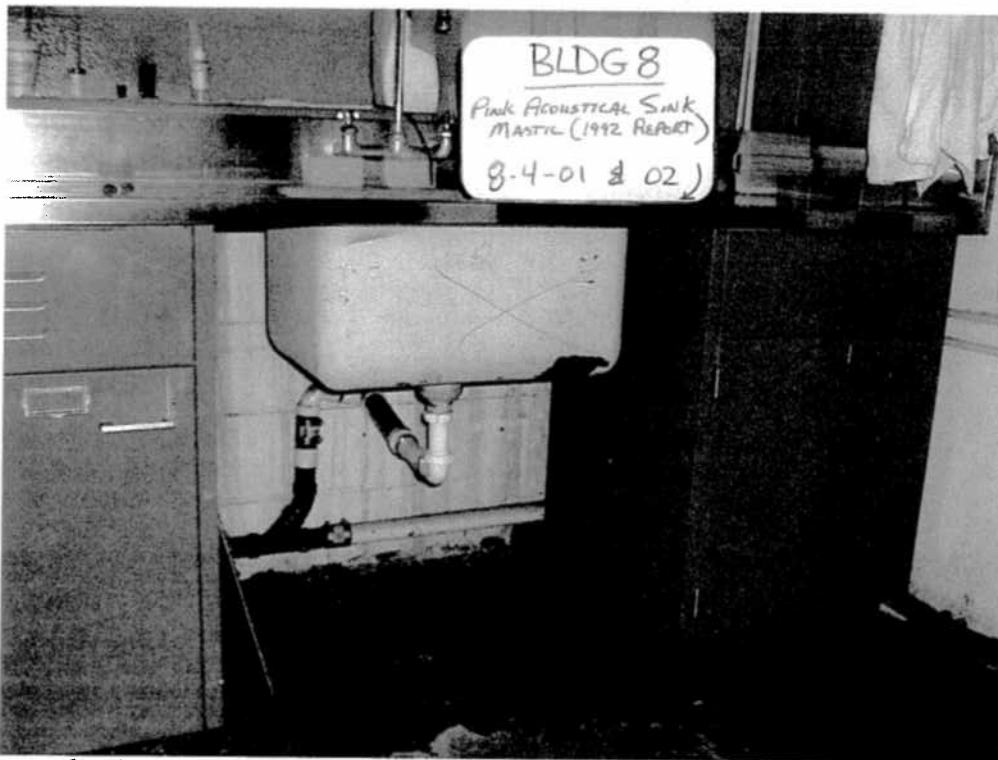
- 8) View of asbestos, pink acoustical sink mastic found in the controller's room in Building 8 during a 1992 inspection.

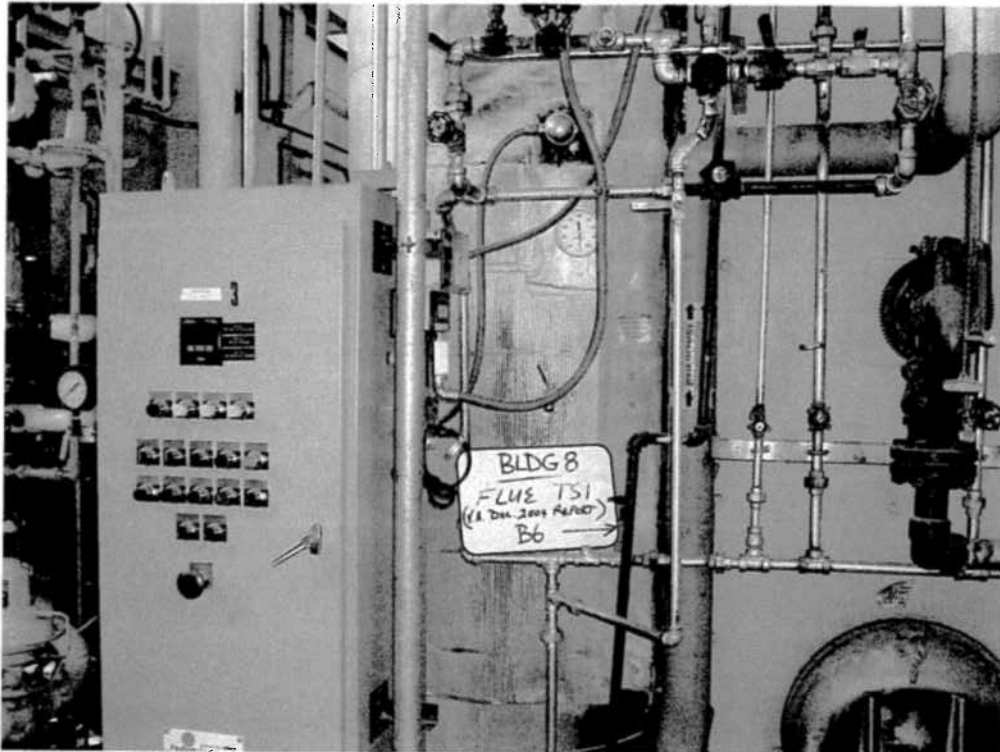
- 9) View of asbestos TSI (painted orange) on a flue between a boiler and a boiler stack in Building 8. This material was found on boilers #1, #2 and #3.

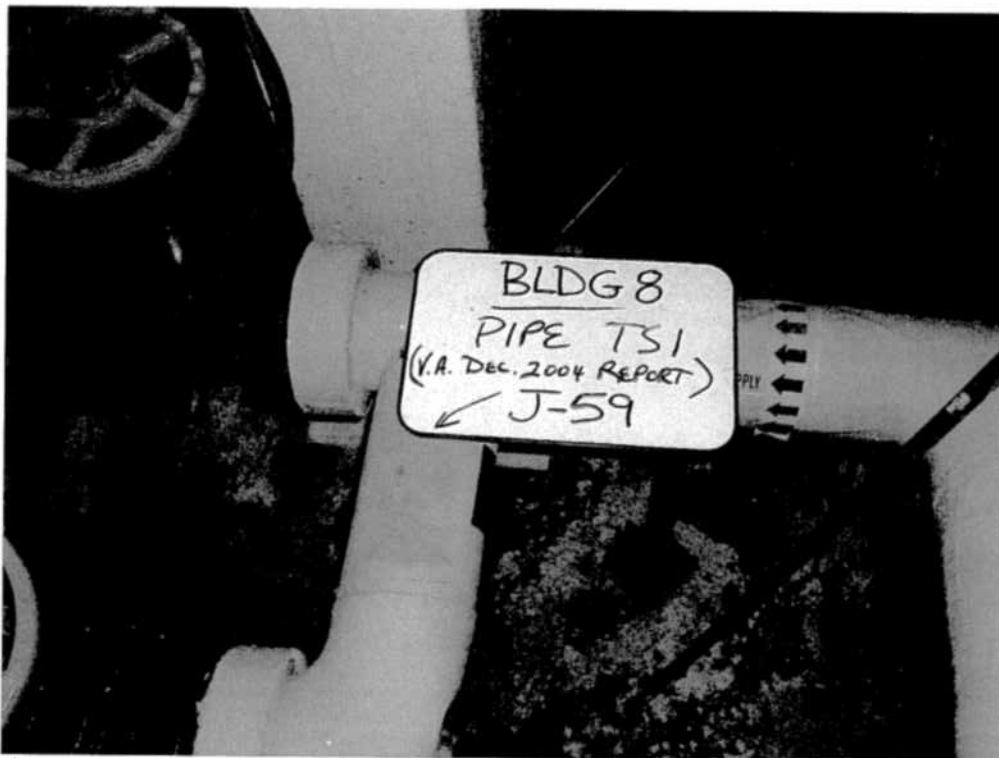
- 10) View of asbestos pipe TSI found in the tank area adjacent to the workshop in Building 8 during a December 2004 inspection conducted by the V.A. Medical Center.

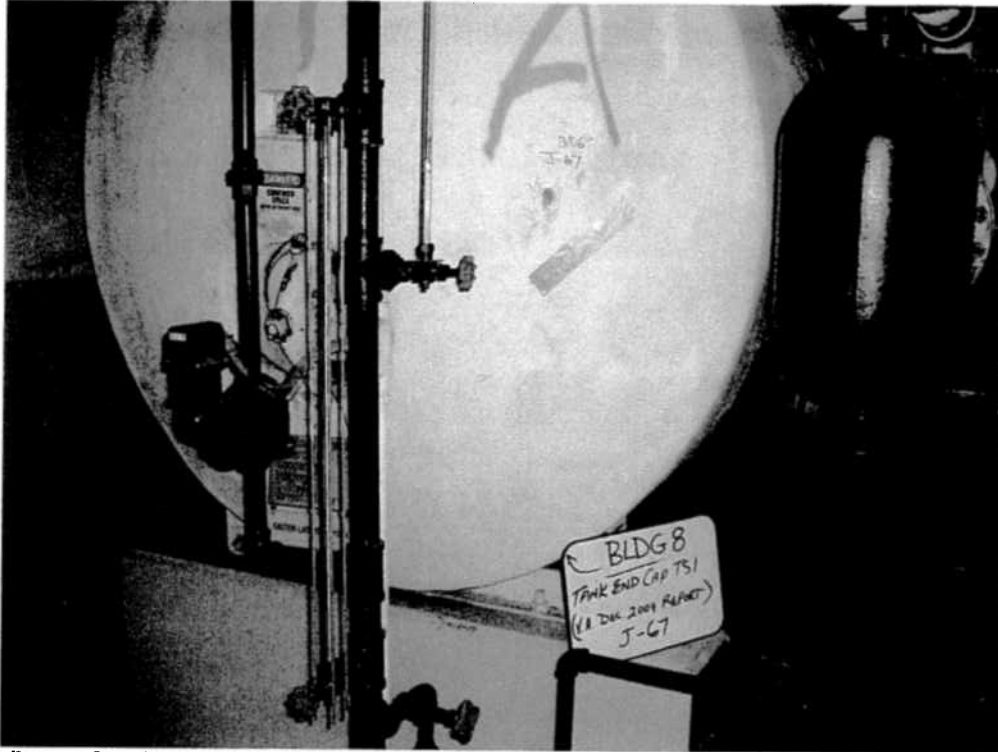
- 11) View of asbestos end cap and tank TSI found on the tank located near the workshop in Building 8 during a December 2004 inspection conducted by the V.A. Medical Center.
